April 4, 2011

Waste Management of Hawaii
Waimanalo Gulch Sanitary Landfill
92-460 Farrington Highway
Kapolei, Hawai'i 96707

Subject: Liner Damage Assessment, Repair, and Construction Quality Assurance Report
for Cell E6 Sideslope, Waimanalo Gulch Sanitary Landfill, Kapolei, HI

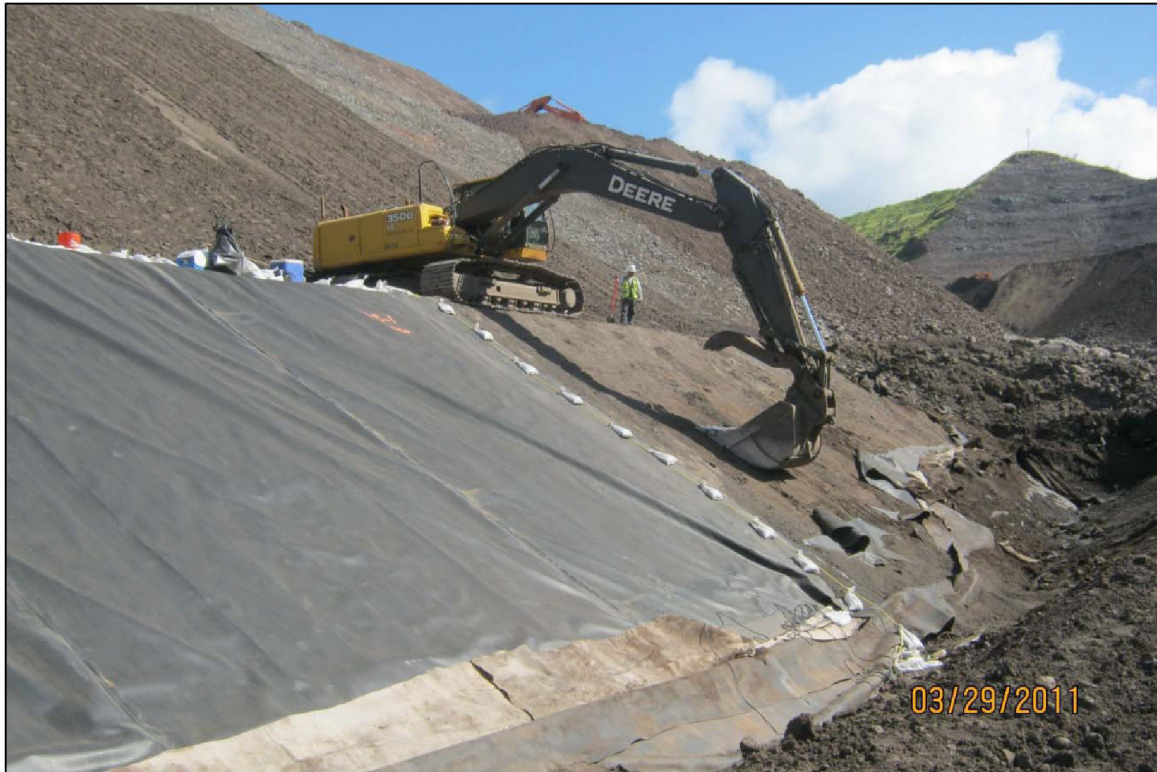
Photo 1: Excavator preparing subgrade of the northern portion of the northern repair area, looking north.

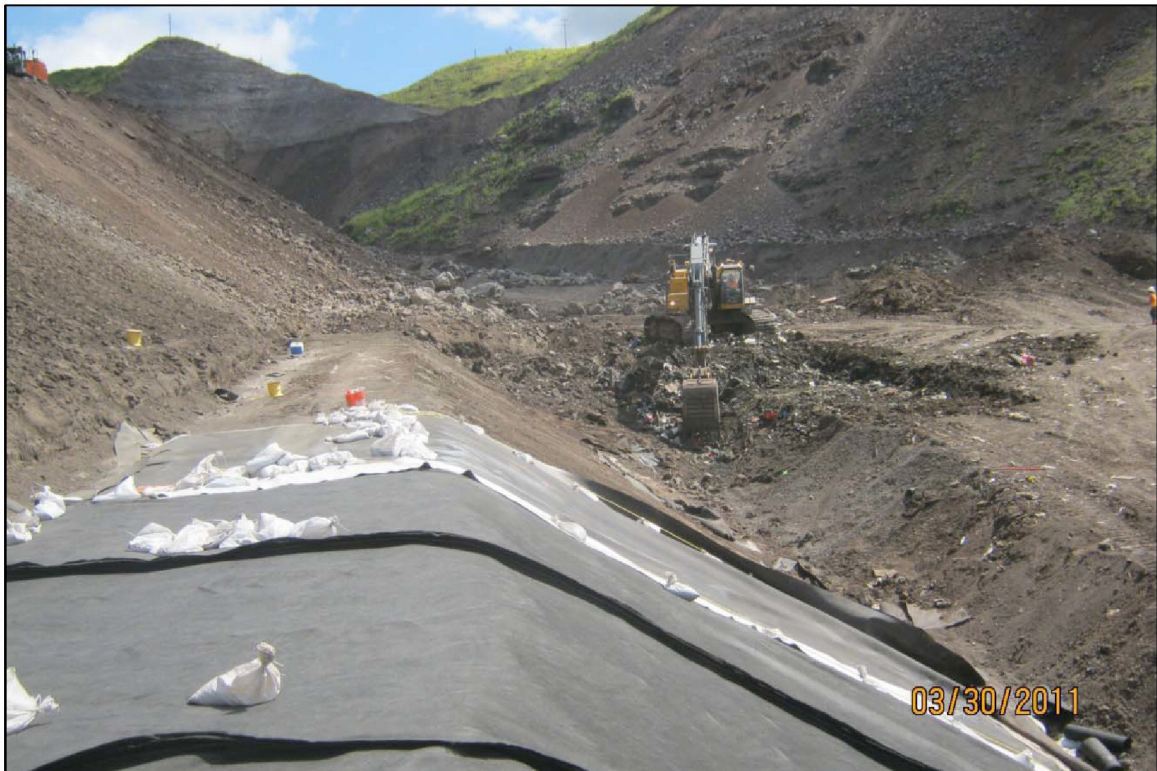
Photo 2: Excavating MSW to expose the northern portion of the northern repair area, looking north.

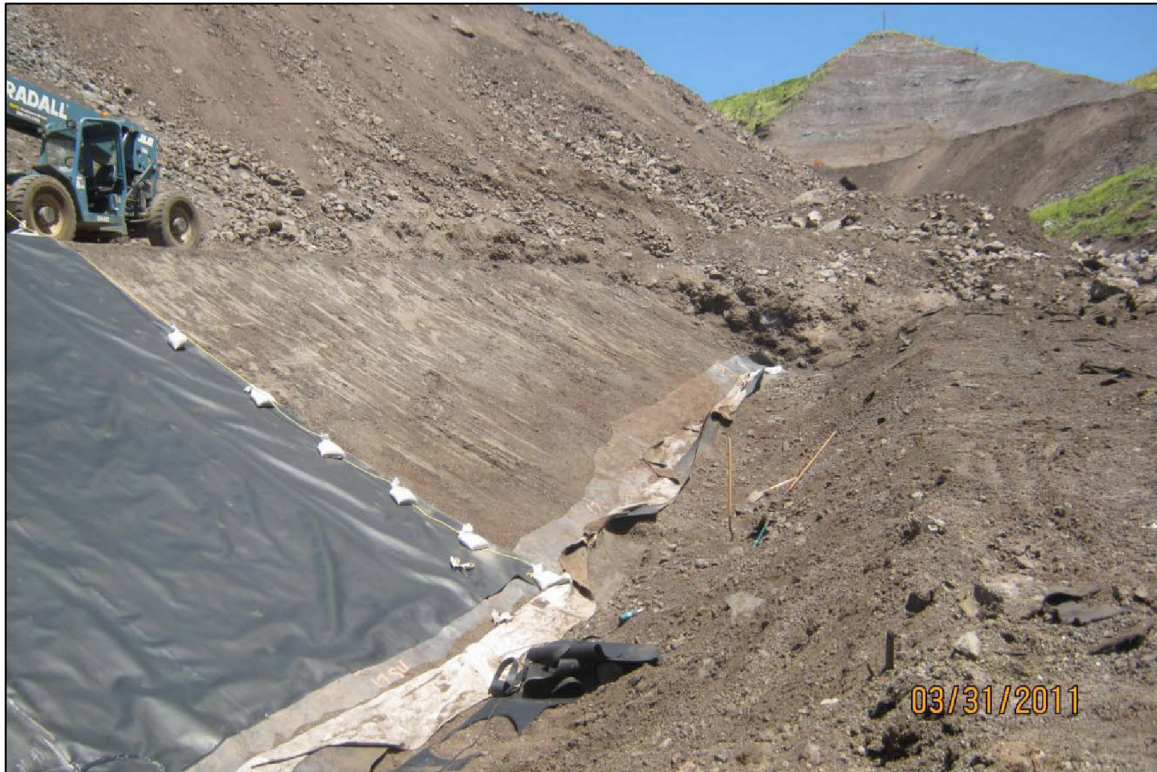
Photo 3: Northern portion of the northern repair area prior to deployment of 40-mil geomembrane.

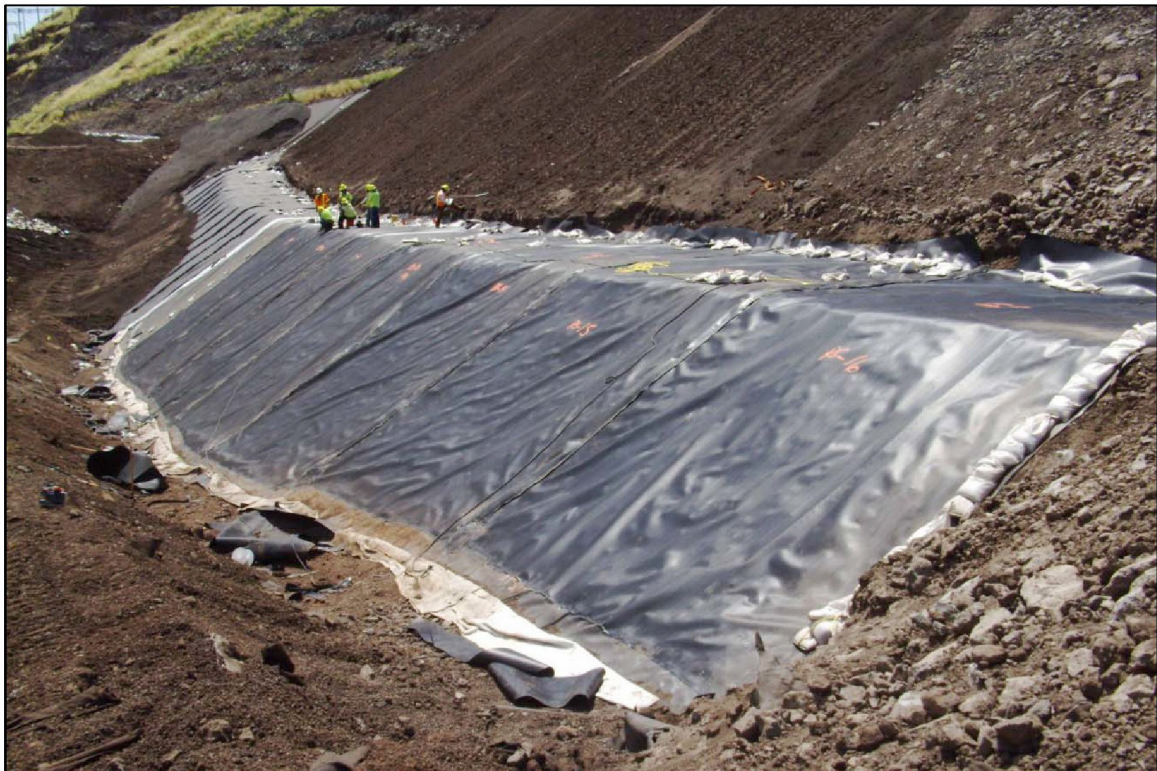
Photo 4: 40-mil geomembrane repair panels on the northern portion of the northern repair area, looking south.

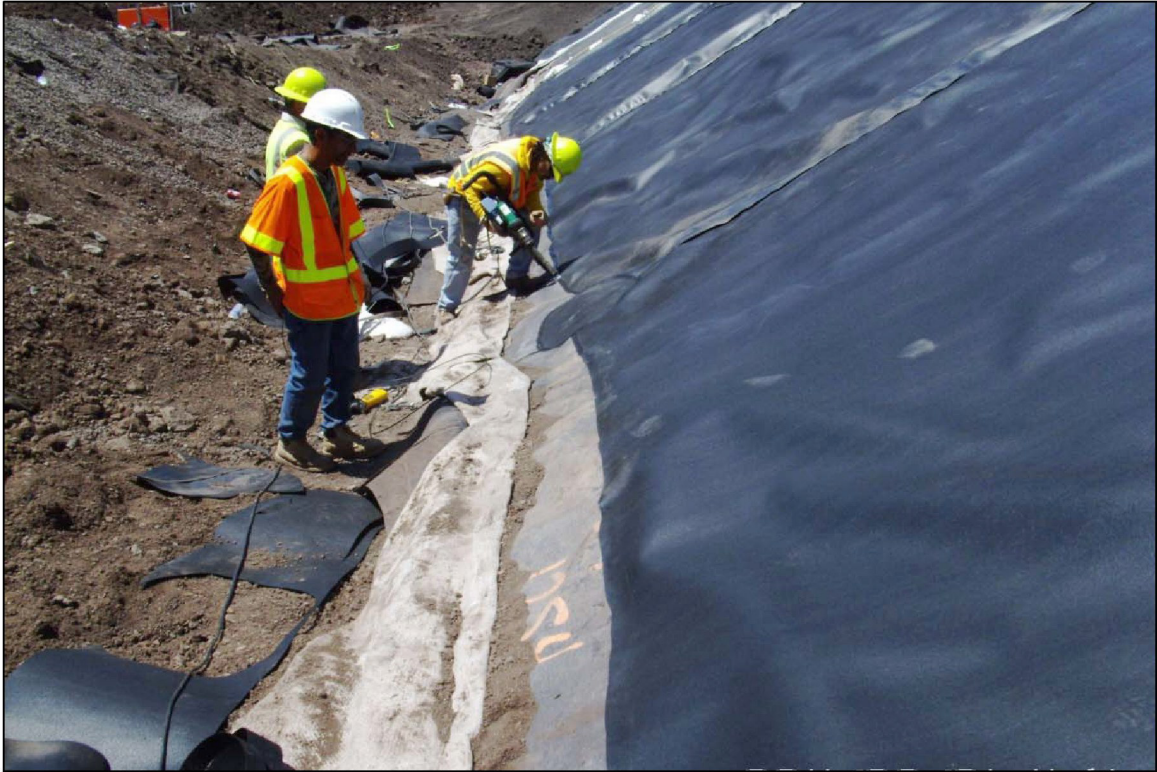
Photo 5: Extrusion welding the 40-mil geomembrane repair panel tie-in to the existing E6 liner system.

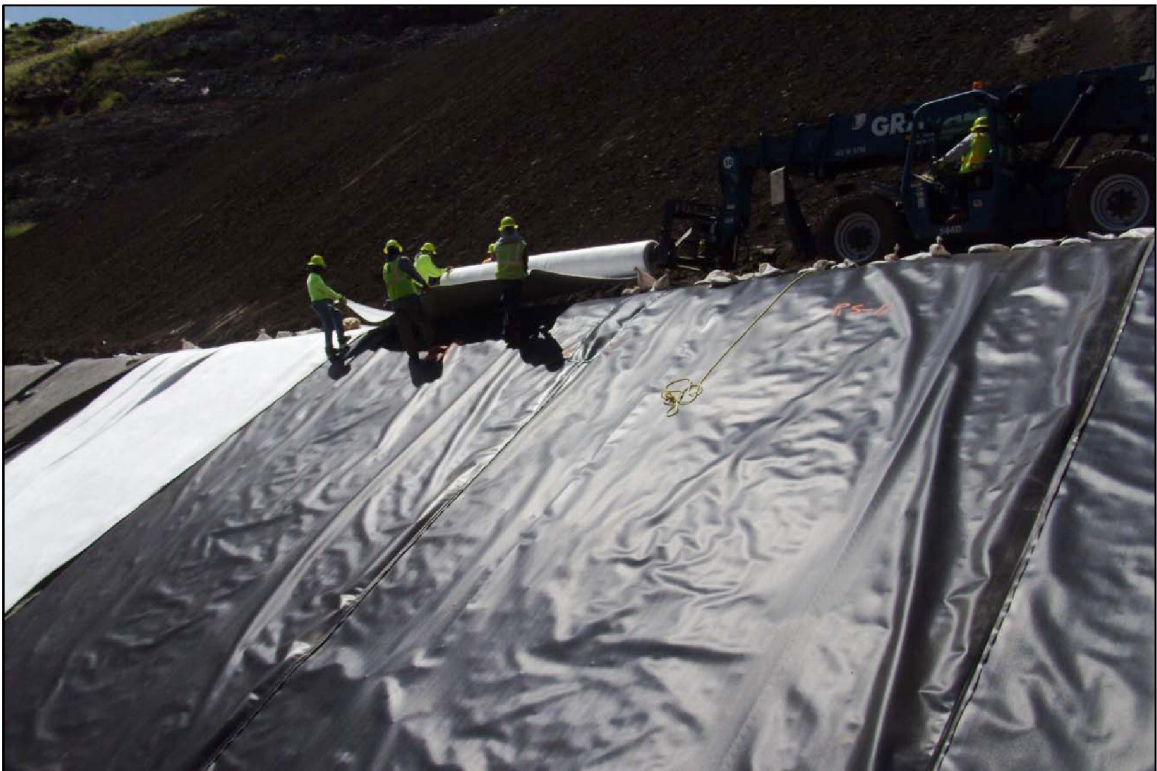
Photo 6: Deploying GCL over the 40-mil geomembrane repair panels on the northern portion of the northern repair area.

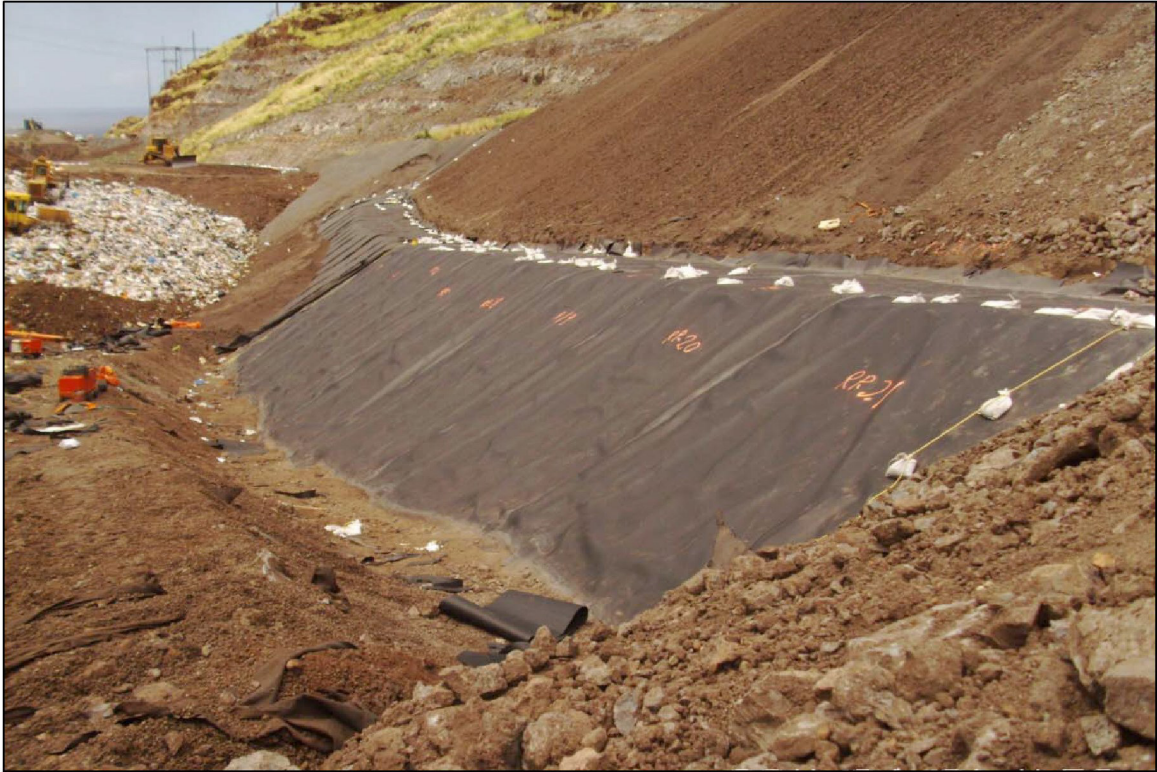
Photo 7: 60-mil geomembrane repair panels on the northern portion of the northern repair area, looking south. .

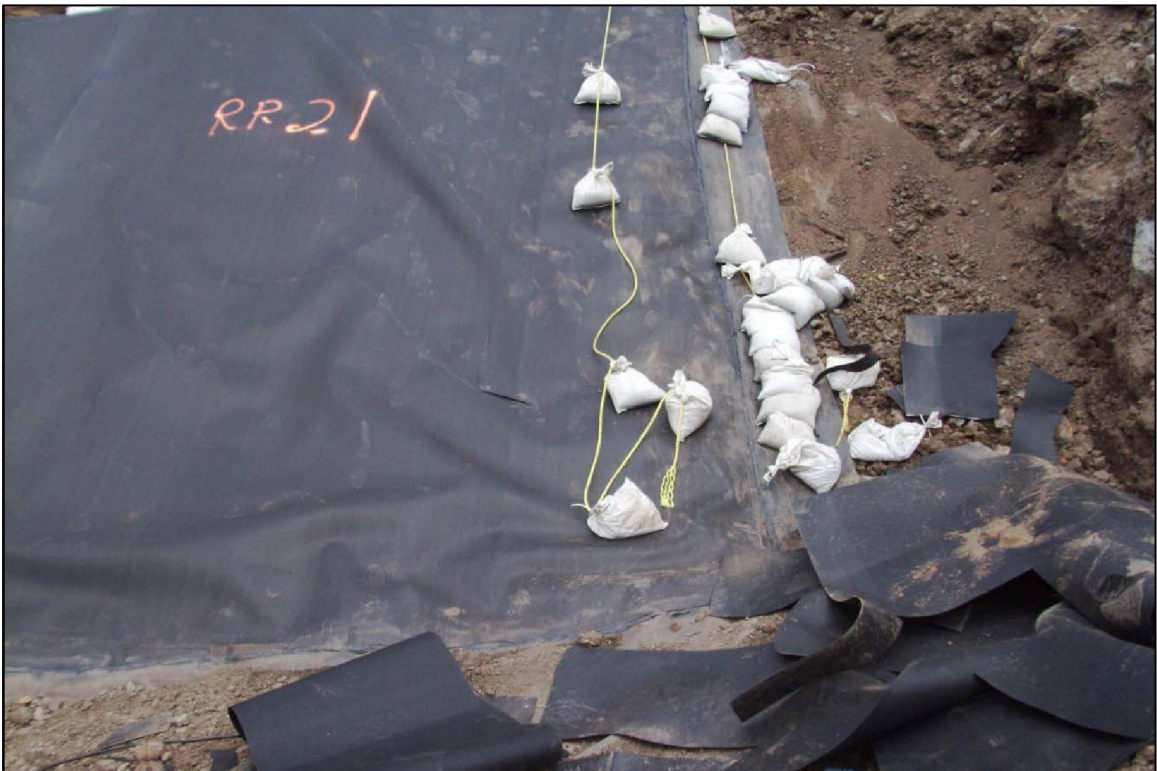
Photo 8: Encapsulated weld along the northern edge of the E6 liner system following installation of repair panels.

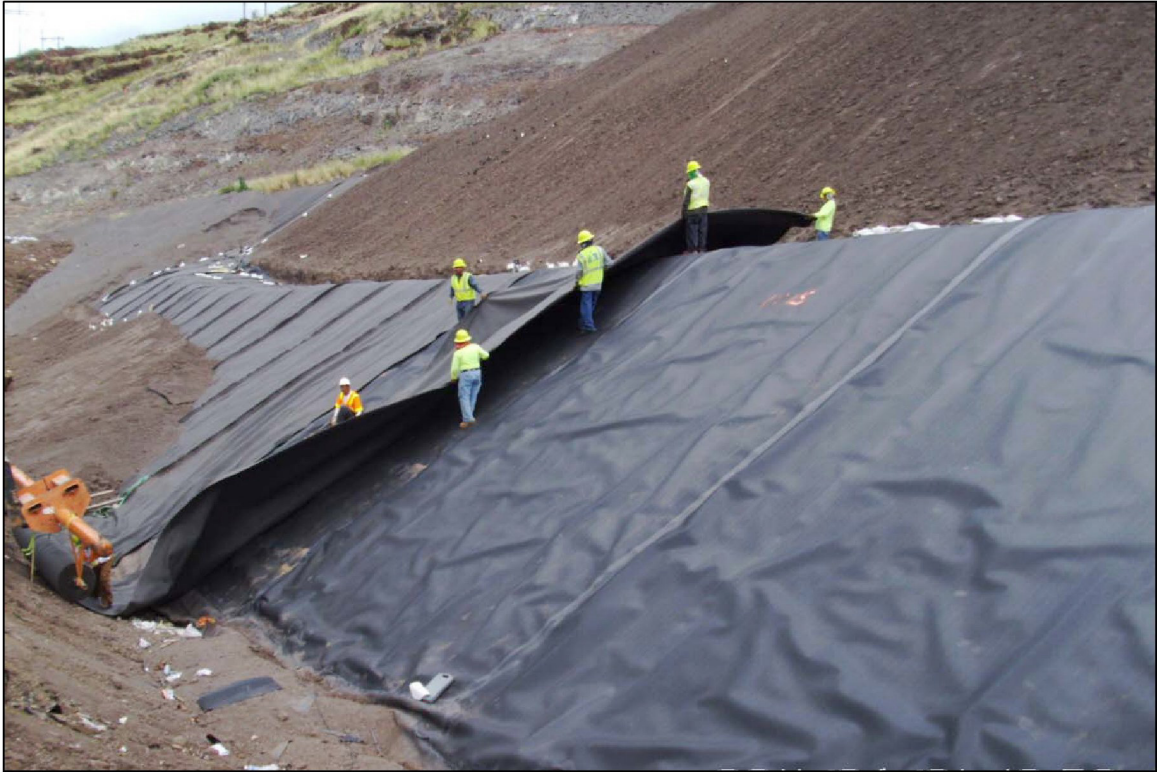
Photo 9: Deploying 16-oz geotextile over the repair panels on the northern portion of the northern repair area, looking southwest.

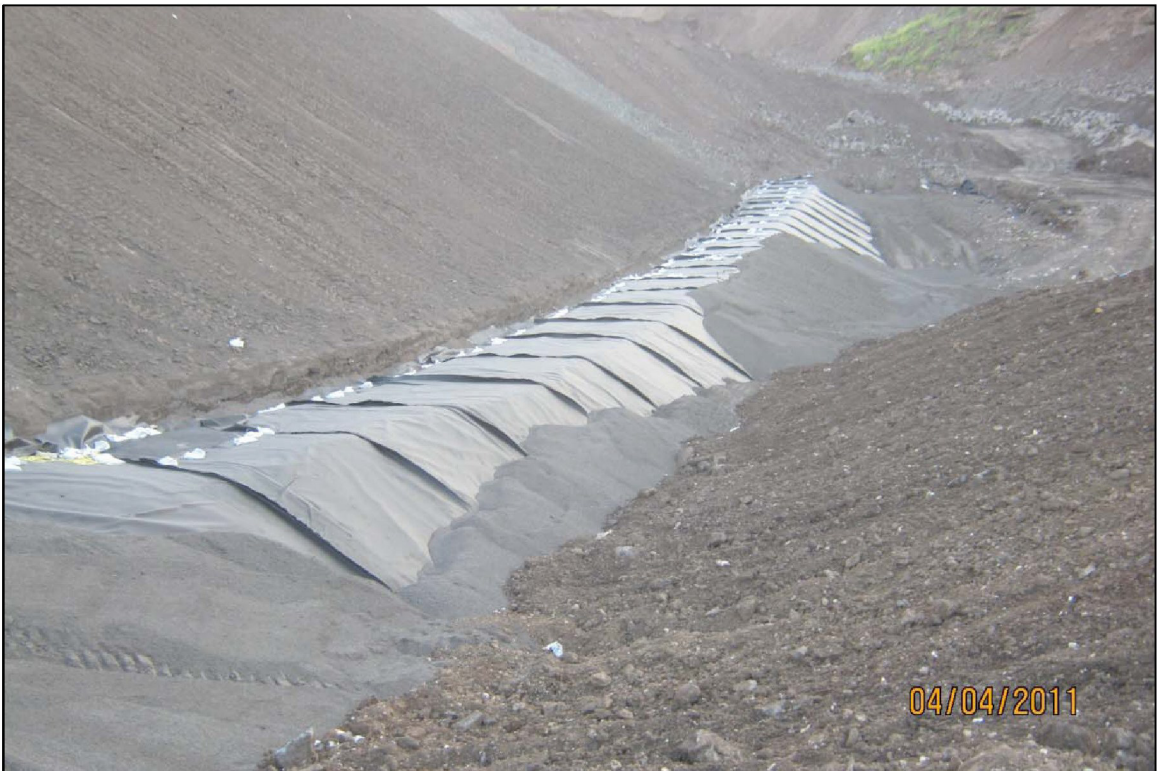
Photo 10: Operations layers on the northern portion of the northern repair area, looking north.
